Border Green Infrastructure Forum

May 2015

Park and Ride Facility – Glendale

AZ

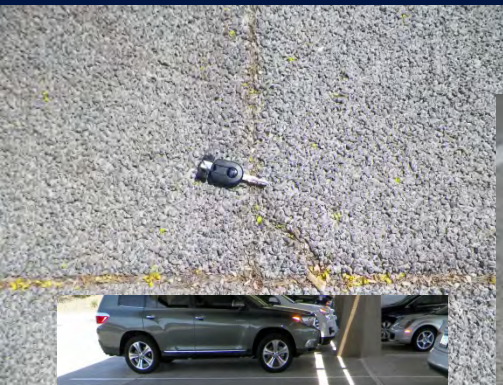
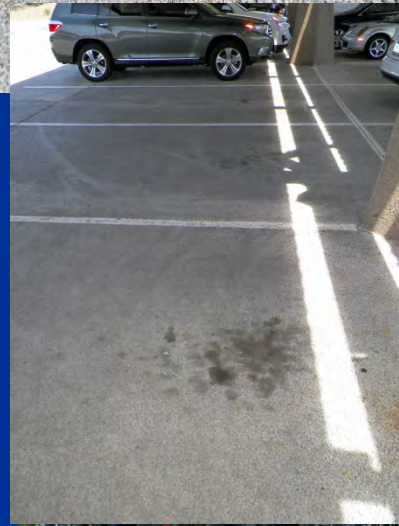
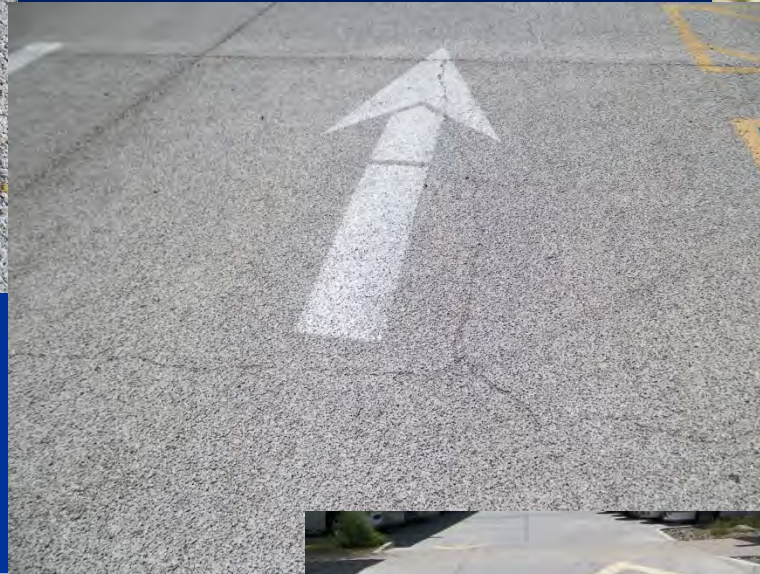
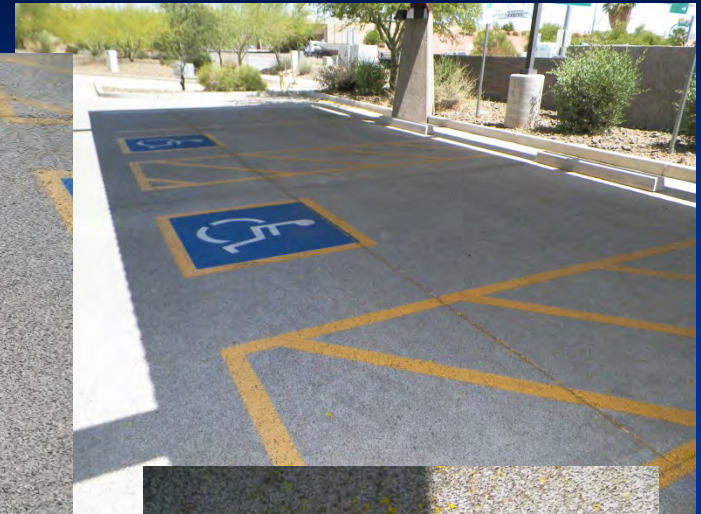
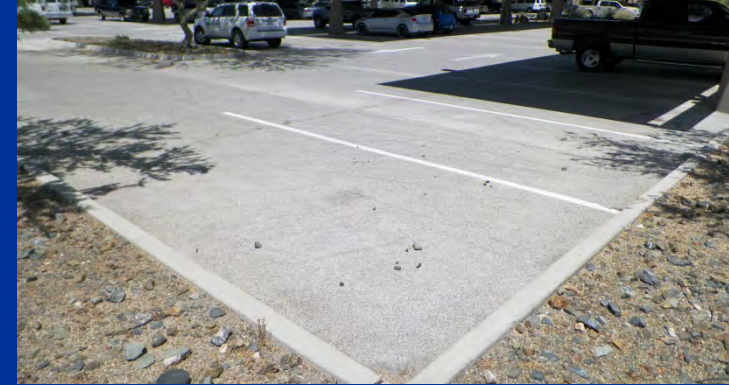
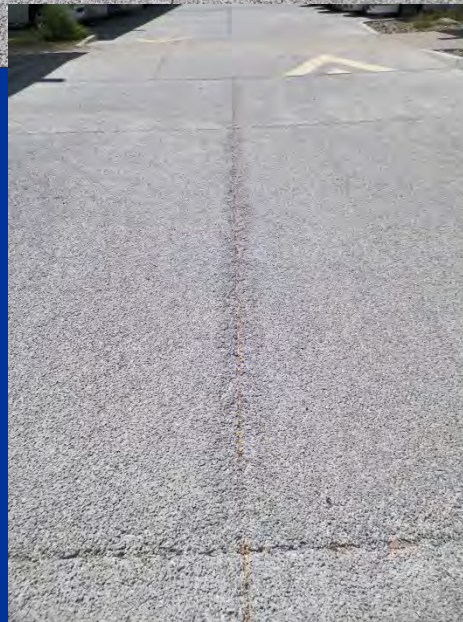
April 2015 (86 months old – 7 yrs. +)

- Park and Ride has exceeded our expectations at the 7 year mark
 - Maintenance will be ongoing BUT surface is remarkably “new”
 - Use is at about 70-80%
 - Consideration for new Park / Ride in North Glendale – adjacent to the new river
 - LID Private is being integrated but for retention (require?)
 - LID ROW is being “integrated” at a calculated rate
 - Curb cuts, vegetated swales, bio retention – POST Inspections for NPDES

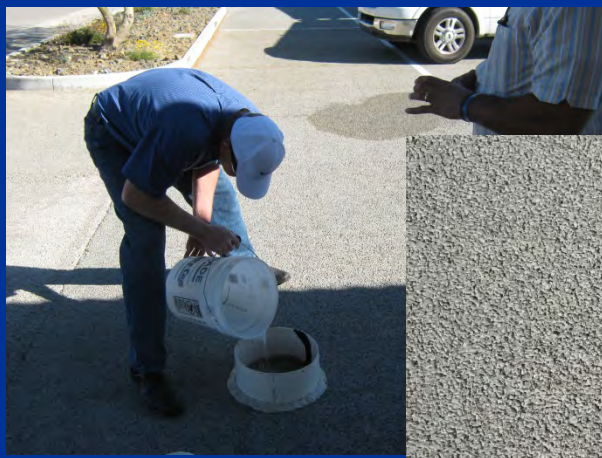
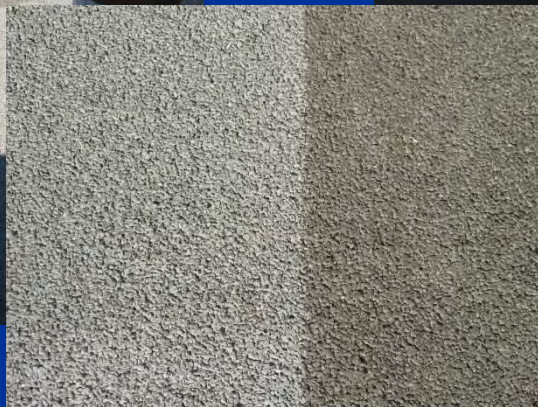
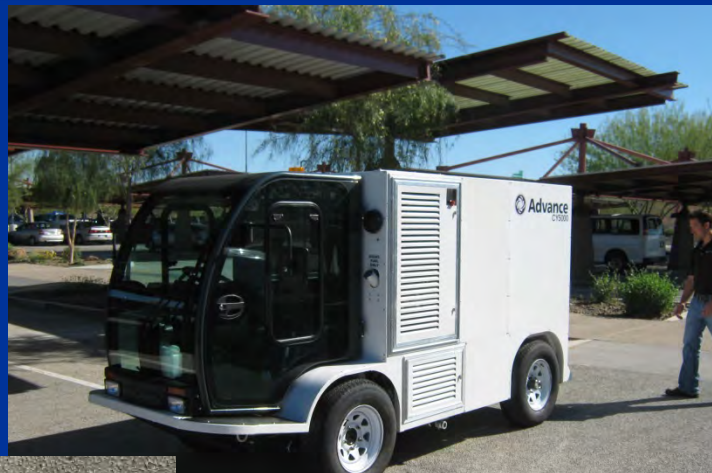
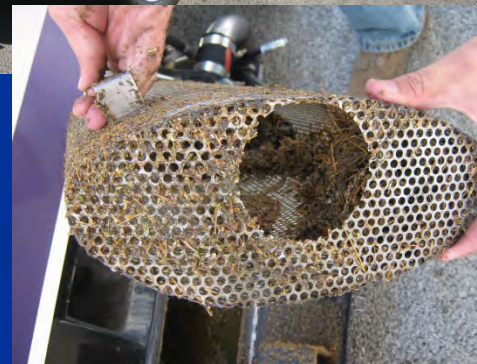
| Total Seconds for Test | Total Inches Per Hour Test 8 lbs |
| 91 | 77.5 |
| 53.6 | 131.5 |
| 69.8% | |
| 38.8 | 181.7 |
| 36.9 | 191.0 |
| 5.1% | |
| 59.4 | 118.7 |
| 51.2 | 137.7 |
| 16.0% | |

- Flush 4 times / yr. using water truck (remote)
- Inspect joints for cracks / debris
- Personal involvement
- Past maintenance
 - March 2012 (48mos)
